TO ALL ROOTES GROUP DEALERS

SUBJECT: PETROL PIPES FOULING BRAKE PIPES

MODEL: LIGHT CAR RANGE (EXCEPT ALPINE)

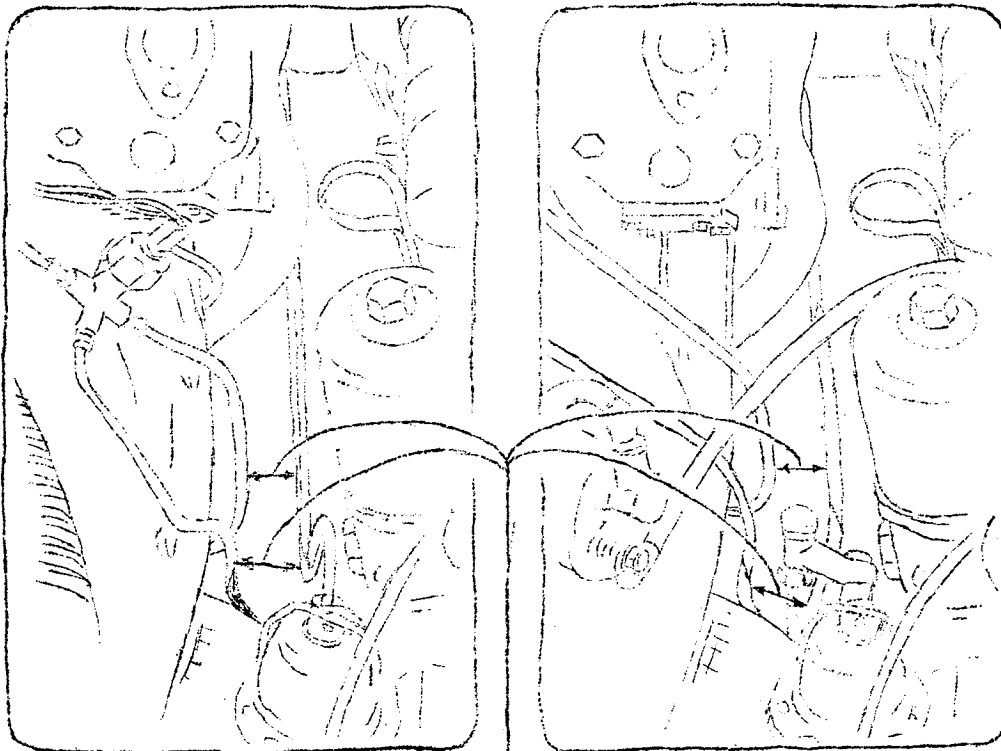
Fig. 1.

It has been brought to our notice that a condition may arise in service where the feed pipe to the petrol pump can possibly foul either one of the two brake pipes leading down the O/S front wheel arch from the 4-way brake union.

Special care should be taken to ensure that after work on the fuel system, engine etc., there is at least one inch clearance between the petrol and brake pipes. Fig.1 shows the pipe layout on the Light Car Range other than Super Minx, Vogue and Alpine. Fig.2 shows the layout on the current Super Minx and Vogue.

MINIMUM 1" CLEARANCE

Cars coming into your workshops for servicing should be checked.
